Limited Visual Dam Safety Inspection Summary Report

MA-082

HC&S Reservoir 70

Limited Visual Dam Safety Inspection Conducted on: 04 April 2006

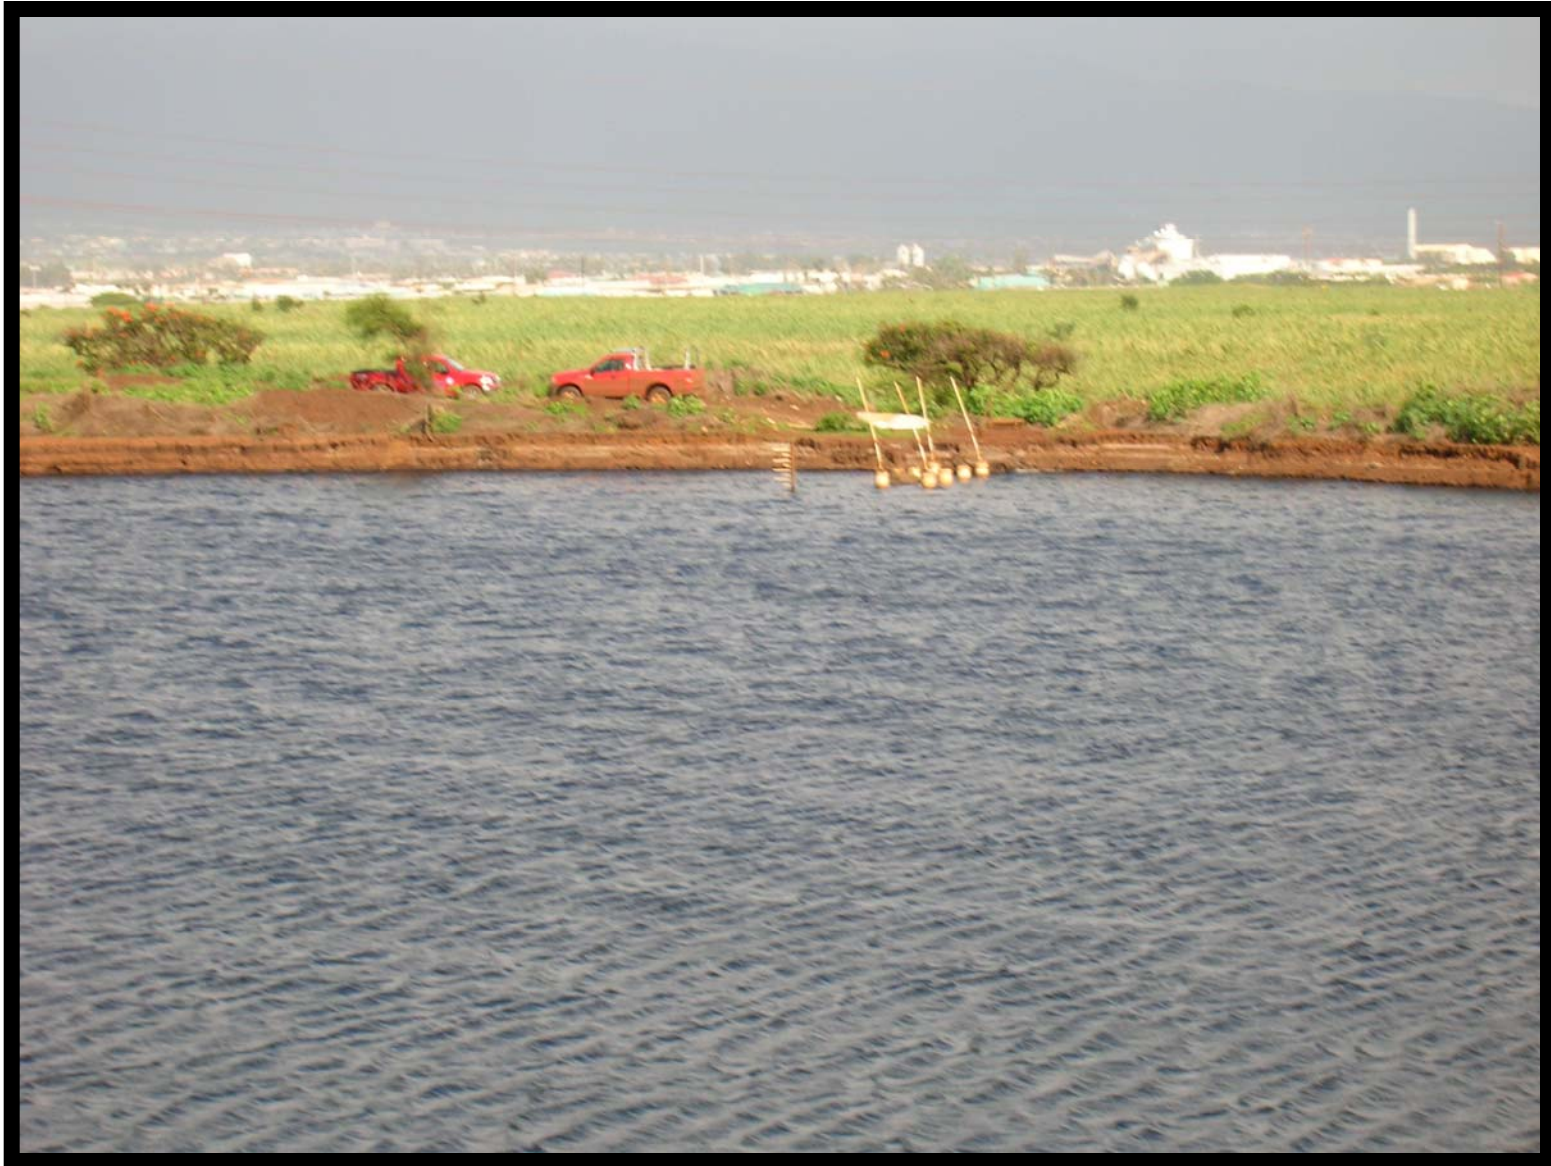
082 crest 2

Erosion, cracks and sinkholes were not observed.

- a. The dam crest appeared to be in satisfactory condition, no corrective actions are required at this time.
